# Manhole Inspection Summary

Manhole # S37GG1027MH

Insp Date: **1/10/07 5:08 PM**

**Location** Address: **226 39 TH ST**

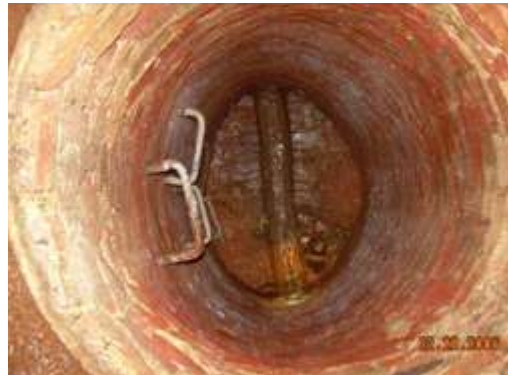
Top View

Corroded steps. Bench debris.

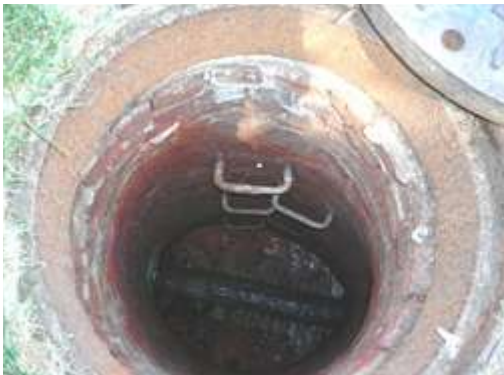
Defect

Frame leaks. Corbel deterioration and infiltration. Barrel infiltration - other side.

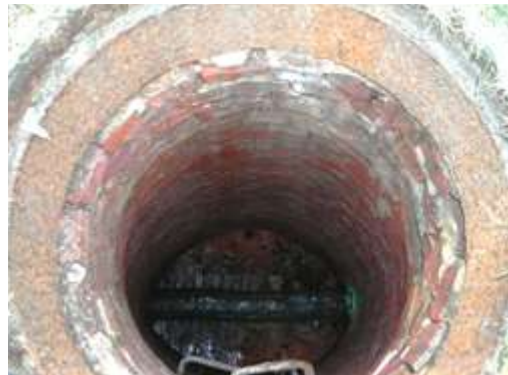
Defect

Frame leaks. Corbel deterioration and infiltration. Barrel infiltration.

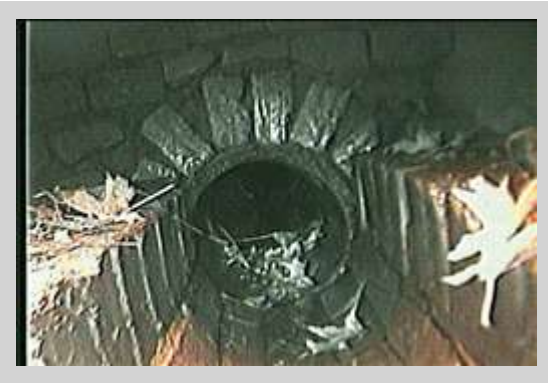
### 8 in. Circular Gravity Sewer Pipe Out @ 12 O'Clock

Channel deterioration.

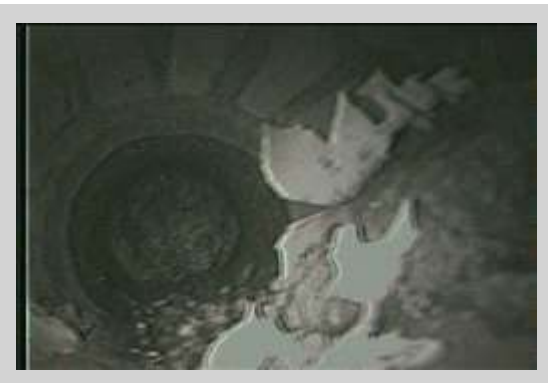
### 6 in. Circular Gravity Sewer Pipe In @ 5 O'Clock

Infiltration: **None** Pipe Seal Cond: **Broken**

Connects To: **Stub connection / abandoned**

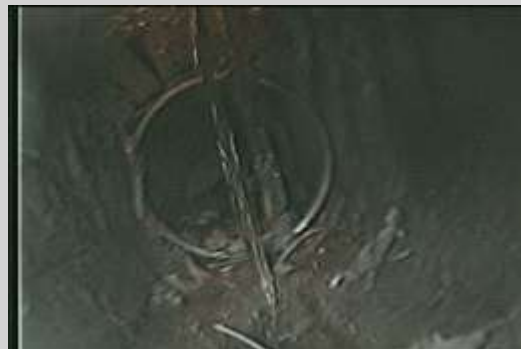
Drop In @ 6 O'Clock

Infiltration: **Evidence**

Drop Condition: **Clogged**
